CASE STUDY

1000 SF GARAGE, HEAVY SPALLING, MULTIPLE CRACKS, RAINY CONDITIONS

Citadel Floor Finishing Systems

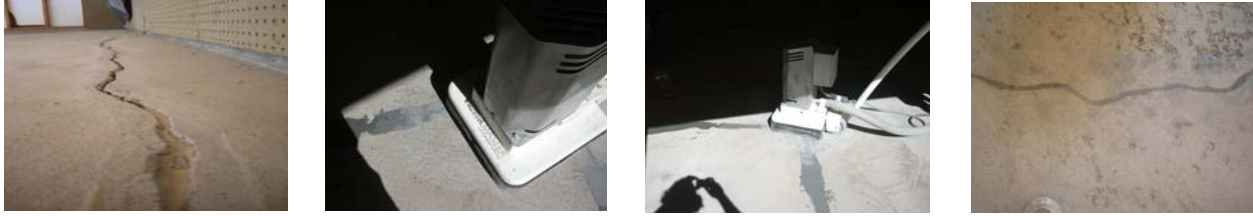
With a large number of lineal feet of crack to chase and fill, we chose to use the CFFS TX-3 mixed with sand to make the repairs. First, all the cracks were chased out using the Metabo hand grinder with crack chase blade attached. They were then all vacuumed out to remove any dust and debris prior to filling. We mixed a total of 32 oz. of TX-3 (16 oz. A, 16 oz. B) and added about 20-30 ounces of dry silica sand as a filler. The mixed material was poured in place and then troweled using a 10" putty knife to spread it evenly. We did this due to the large amount of spalling located around the areas where the cracks had formed. Eventually all these areas needed to be filled to help level out the floor so it worked out quite well. Some of the cracks were extremely wide and required the use of dry silica sand to fill the voids prior to applying the TX-3. This was done so that the liquid filler would not simply run down the crack and disappear. Once the sand was in place it was struck off using a finger to create a void about 1/8"-1/4" deep for the repair material. For these cracks we used CFFS Fortification Formula with no fillers. The material was batch mixed in small quantities and poured in place. Because there was somewhat of a hump in the floor due to heaving, we had to come back and fill in some areas that had run downhill. While doing this we added dry silica sand to the poured material to thicken it up and force it to stay in place. Once all the repairs had cured we used various grinders to remove the overfill. (See next page)

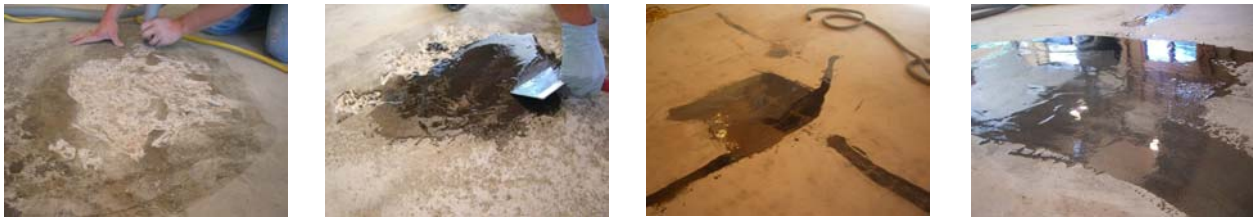
An area that was heavily spalled also turned out to be the spot the homeowner told me was the frozen "bird bath." To remedy this area we again used the TX-3 mixed with dry silica sand to overfill and level the floor. It was an area however that the Werkmaster Raptor could not prepare so we used the Metabo hand grinder to purposefully gouge and clean the surface so that the repair material had a strong base to bond to. The area was vacuumed, and we mixed a batch of TX-3 with sand to fill the majority of the hole. Once this was done, a second batch was mixed without sand to allow it to self-level and flow easier. The end result was a large repair that we ground down using the Werkmaster Raptor, mostly due to its larger footprint and flatter grinding capabilities when compared to the Hum-B or hand grinder.

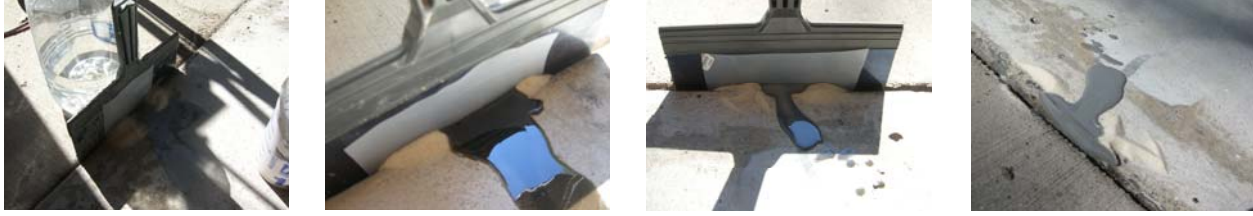
There were also a number of repairs to be made on the front lip of the garage slab where it meets the driveway. These were done quickly and easily using CFFS Fortification Formula, plastic sheeting and a 10" putty knife. To make the repairs we used the Metabo hand grinder with the crack chase blade to open up and prepare the damaged areas for filling. We vacuumed the area to remove all latent dust and debris then put our forms in place.

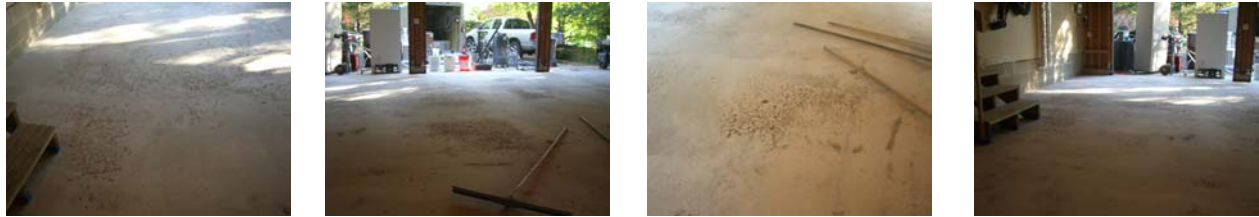
Once the Fortification Formula had cured we used the Metabo 5" hand grinder to remove the overfill and profile the radius to match that of the existing slab. When we were done you could not even tell that there was any damage to begin with. For this particular application there were about 6 areas that had damage, and all of them were completed in about 25 minutes. At this point all the necessary repairs had been made (except for the spalling, see below) and we were ready to start applying the liquid materials.

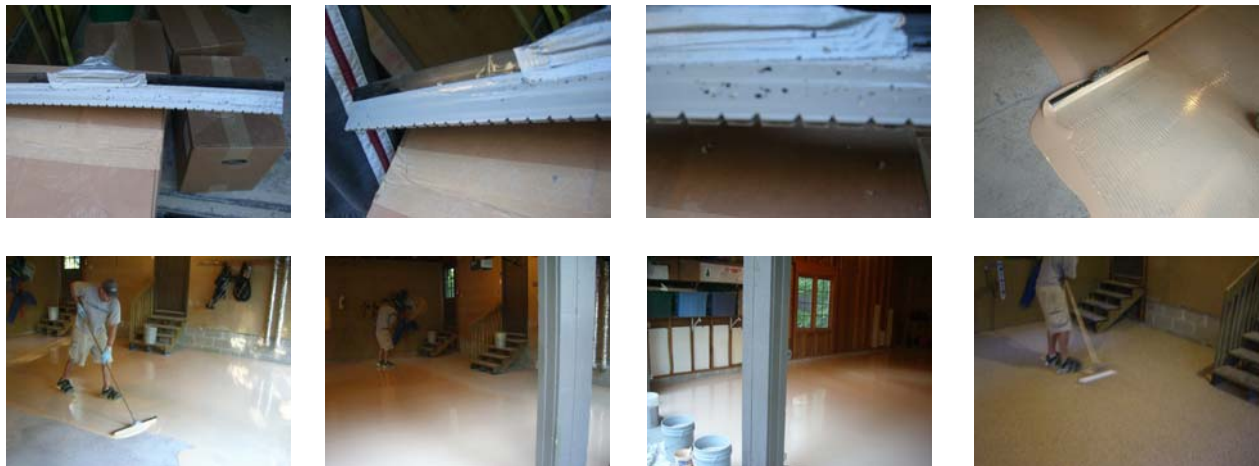
Because we were going to use color tinted Polyurea-350 as a self leveling coating to fill the spalling, we decided to expedite the spreading of the material by carving small notches in a standard squeegee to allow it to leave material behind as we pushed it around the floor. After the material was spread with the notched squeegee it was back-rolled to lay it off and even everything out. By doing this we were able to "wet-out" the entire floor in about 45 minutes. From there, we waited about 15 minutes before we went back and did a full broadcast of ¼" Tan chip. Because we had "wet-out" such a large area at once, we decided to use a dry roller to go back over the broadcasted chip and force it into the coating, thus guaranteeing uniform coverage throughout.
