CASE STUDY

EXTERIOR QUARTZ STAIRCASE

Citadel Floor Finishing Systems

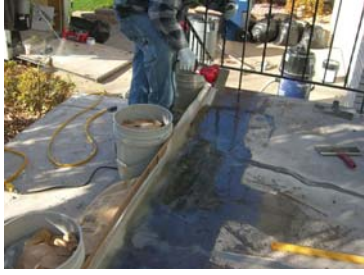
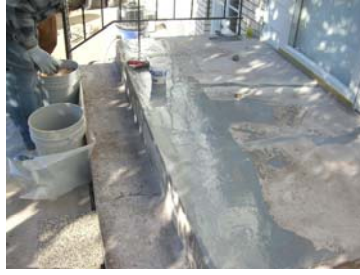
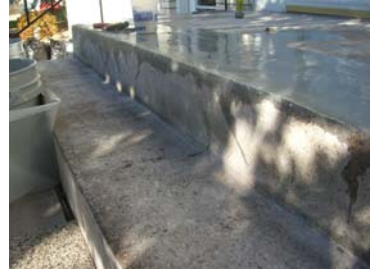
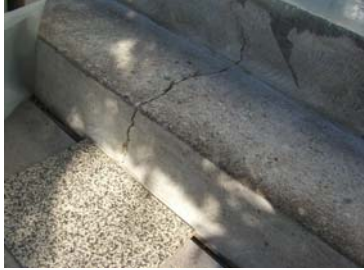
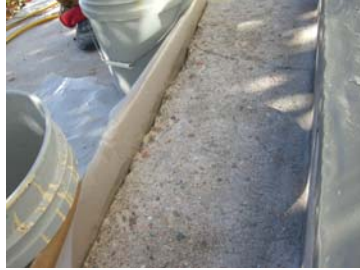
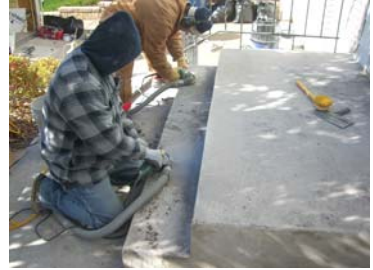
FRAME BY FRAME INSTALLATION PICTURES

Heavy spalling on the top and second step due to harsh Minnesota weather and the freeze/thaw cycle. Most of this was due to the lack of gutters on the home and constant rain/snow dripping on the concrete and slowly deteriorating it.

Stop the deterioration of an exterior concrete staircase and provide traction by installing a decorative Polyaspartic Polyurea floor coating.

CFFS Fortification Formula
CFFS PR-511 Primer and corresponding tint
CFFS PG-100 and corresponding color tint
CFFS Decorative Color Quartz – Blend B
