ROCKFORD MEMORIAL HOSPITAL – ROCKFORD, IL.

HELICOPTER LANDING PAD ON ROOF OF FOUR STORY BUILDING

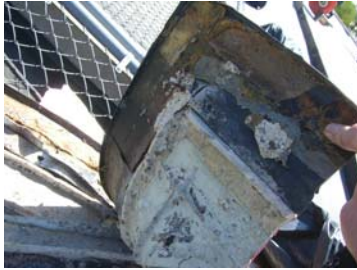
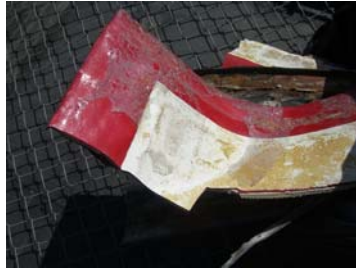
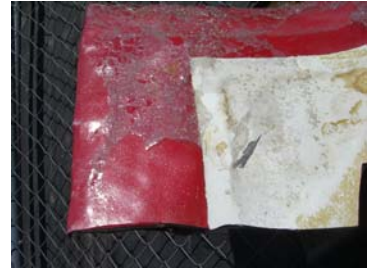
The above pictures show the existing / failing coating after it has been removed from the concrete.

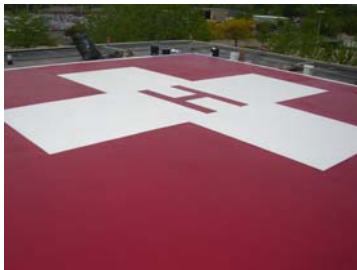
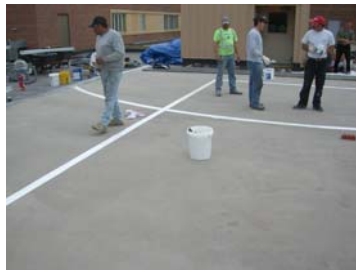
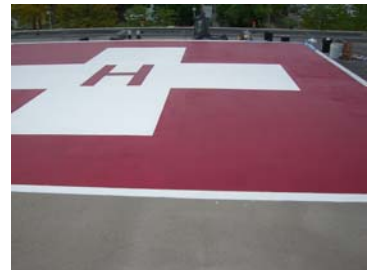
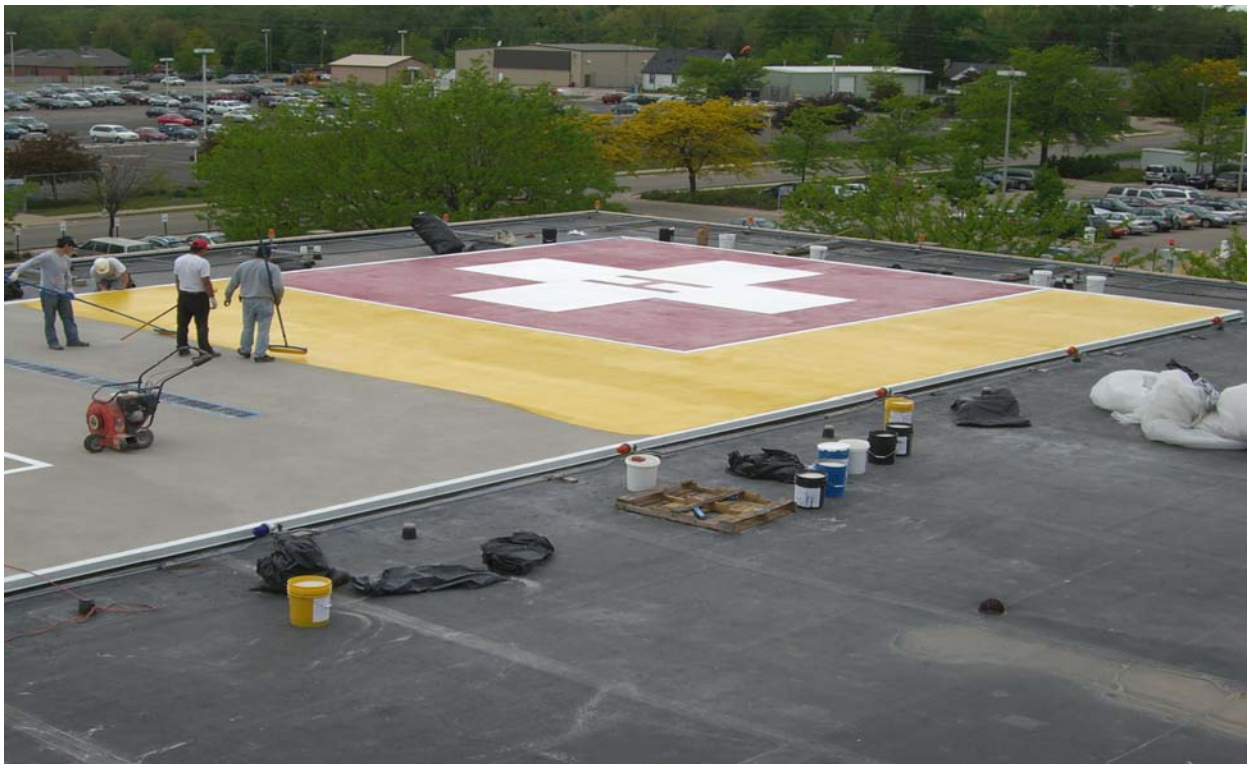
The below pictures show the new Citadel Floor Finishing Systems coating. This coating was chosen for its extremely high strength and wear resistance as well as being 100% UV stable. It is exposed to the elements year round so it needed to be able to hold up to changes in temperature and harsh weather.
